CAROL POWELL

INTERIM REPORT ON MINT BASEMENT

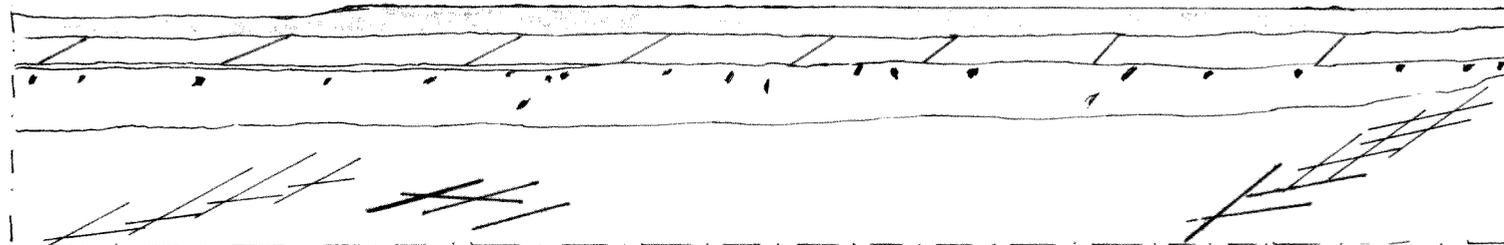
Layer I This was comprised of a very loose matrix of dust with fragments of plaster, small pieces of mortar several laths and occasional fragments of 20th century glass. The appearance of the layer was of material which had gradually settled over a lengthy period of time.

Layer II This was a very compacted composition of broken down mortar. None of the very loose matter from the layer above had been impressed into its surface, both layers were completely discrete. The layer itself was also completely sterile with no extraneous materials appearing throughout its depth of 4 cms. If this mortar layer had been deposited to provide a "floor" then, at least in this area of it, it had not been very much utilized. That it was intended to be a flooring was suggested by the evenness of its surface and by the homogeneous texture of the crushed mortar.

Layer III was a very thin layer of plaster. This layer did not extend all the way across the trench but stopped short of the wall (see plan page 9). The cut off line was sharply defined and gave the impression of having actually finished at that point rather than having been

Layer IV consisted of red-orange clay with a very high proportion of charcoal and was approximately 3 cms deep. Several interpretations of this layer need to be considered.

Layer Va was an extension of the clay layer but without the charcoal inclusions. There appeared also to be some slight difference in the matrix which may perhaps be attributable to the inclusion of some topsoil as outlined above. This judgement, however, may be a subjective one due to the difficulties of removing very compacted layers and to the poverty of the lighting in the basement. At its lowest extremity Layer Va was intersected by a lens designated Vb.

This Layer Vb was of lateritic composition (greyish brown matrix with very high pebble inclusions) Whilst it is at least conceivable that the laterite was deposited by man as a drainage or other purpose layer the lens effect argues against this and suggests that the layer is natural. Again this could be checked outside the building.

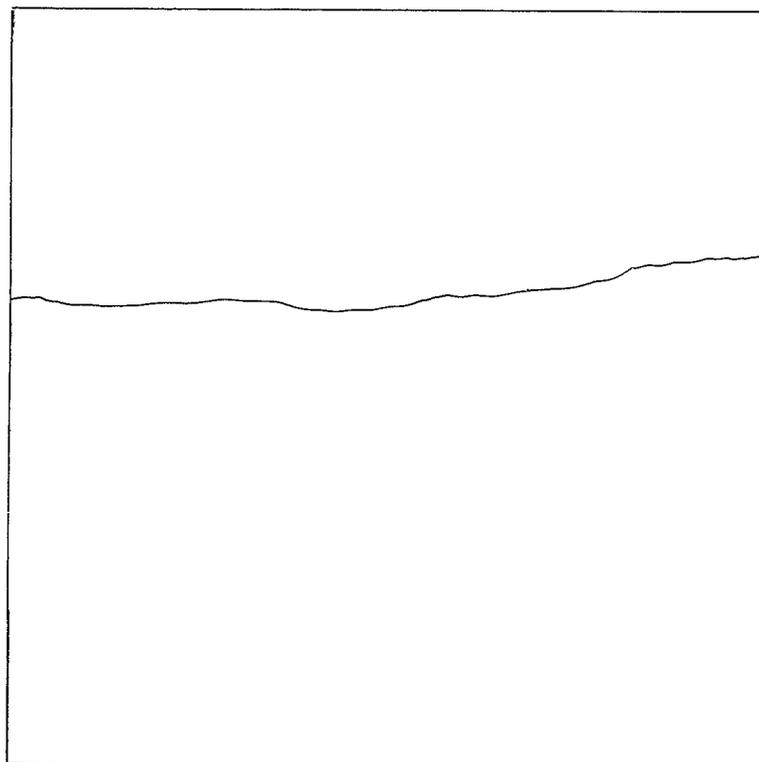
East Wall

worn away. A covering object possibly precluded the dropping of plaster at that point.

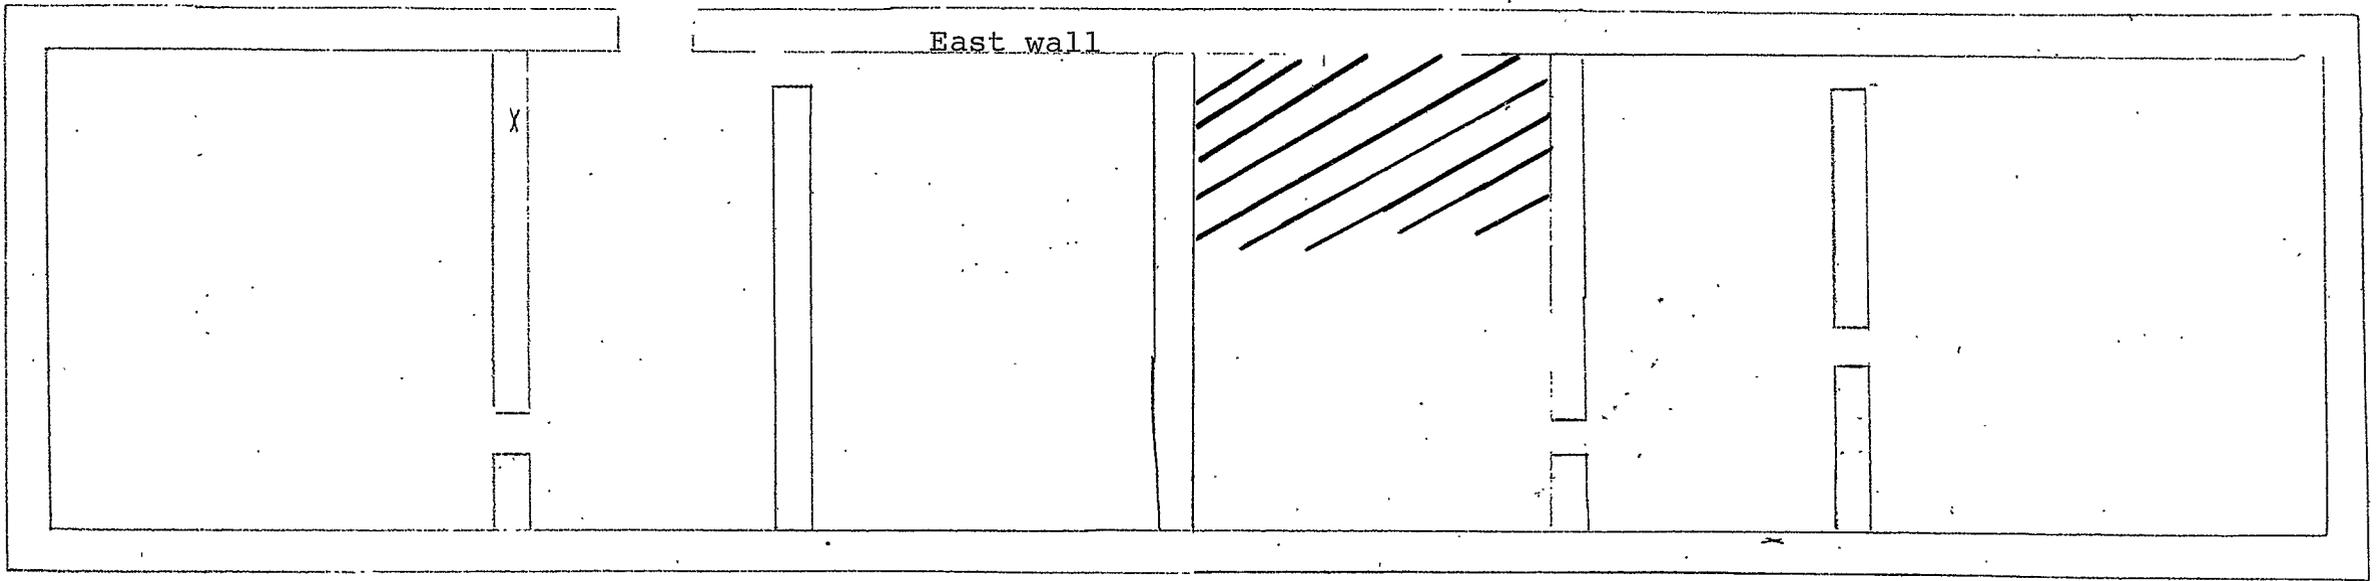
The purpose of the fill on the eastern side of the central wall is not so readily definable. At the time of writing workmen at the Mint have removed only a small amount of this material which consists predominantly of broken down mortar mixed with small pieces of coal or coke. The mortar is generally in a completely crushed form but occasional lumps of consolidated mortar also occur.

As far as could be seen at this stage there appears to be a discrete layer of domestic rubbish below this first layer. This has been no more than partially disclosed but within this small uncovered area could be seen a shoe, bones, glass and brick fragments.

Sketch showing area of Mortar and coke/coal in Mint basement.

it is some 44 cms below the floor boards to the central wall where it is some 60 cms below the boards. At such levels it seems unlikely that it was even intended to support this flooring even before any subsidence of the layers occurred.

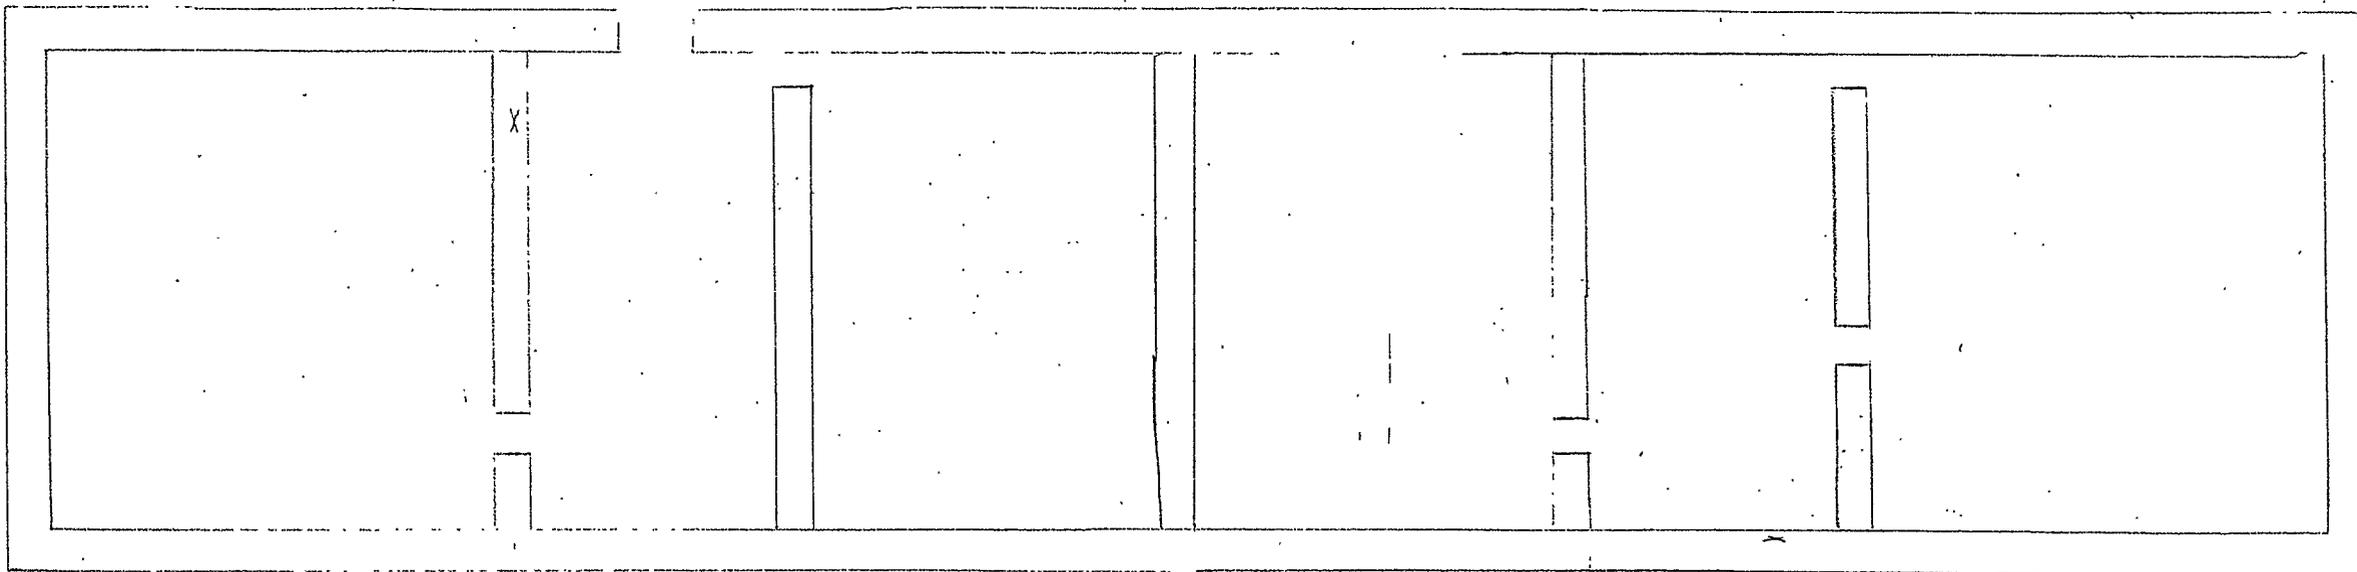
The position of the various doorways in the basement is indicated on Page 16. The position of two possible keystones is also shown. Both of these stones occur in the basement lobby areas although on different walls of each lobby.

That two entrance ways were a part of the original basement area is indicated in the Bigge Report. The report notes that "On the eastern side of the south wing are two doorways into a cellar which is formed in the basement between the wall under the columns and the main wall of the building - over these openings are located lintels of timber...".

Possibly one of these doorways is that later converted into the barrel vault tunnel and shown on the sketch. The other, or its original position, may still be obscured by outbuildings.

Sketch showing doorways into and between different parts of the Mint basement.
