DRAINAGE
REPORT
TIMBER
BARN
ROUSE HILL
HOUSE

By: Dr Robert V J Varman

For: Historic Houses Trust of New South
Wales

JUNE 23, 1997

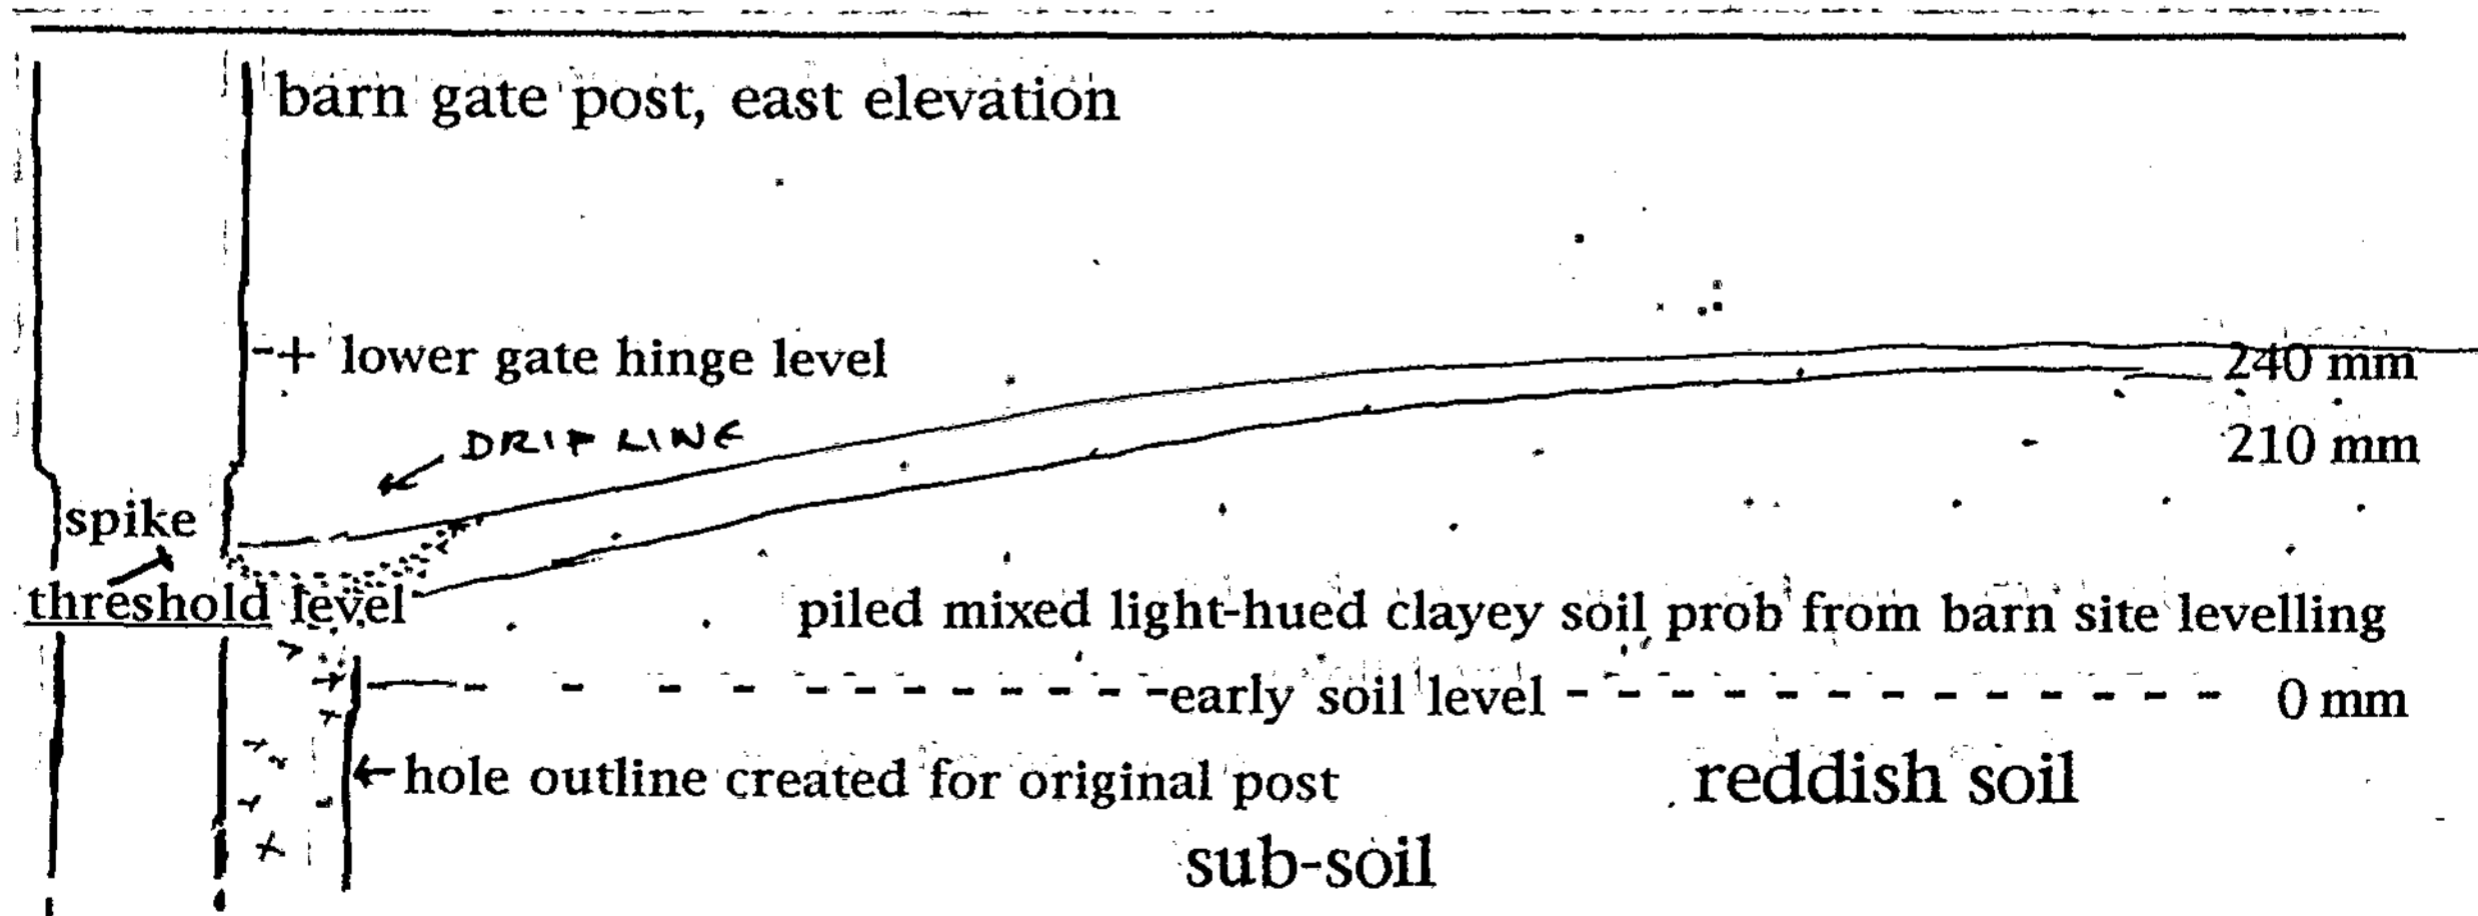
EAST ELEVATION TEST TRENCH CROSS-SECTION

The most important features were found to be:

[A] A reddish clayey soil level, representing the near original ground level. This level was also found on the west side trench with later fill over it. Evidence from the north side of the barn suggests that the original surface soil was of a grey hue.

[B] The compacted dumped clayey soil mix, representing material left over from the levelling of the site for the barn and the excavation of the holes for the upright posts. The soil dump feature slopes both towards and away from the Barn because of the slight hump and the drip line trench along the side of the barn. The latter feature causes the flow of rain water to run along the drip-line trench at the edge of the Barn. The flow of the water is slowed down by the grass and a percentage of the water eventually sinks into the subsoil directly along the side of the Barn, adding to the moisture already under the barn from other sources.

During the initial construction period, excess soil was dumped along the east side of the barn. The excess soil was the result of site levelling and the excavation of holes for the main posts of the barn. The unintended effect of this was to reduce the rate of water run-off away from the barn.

[Option A] Modify the soil build-up to the east and west of the Barn to gently slope away from the Barn by removing soil no deeper than between 50mm-200mm. The 200mm represents the mild 'hump' along the east side of the Barn, east side of the drip line.

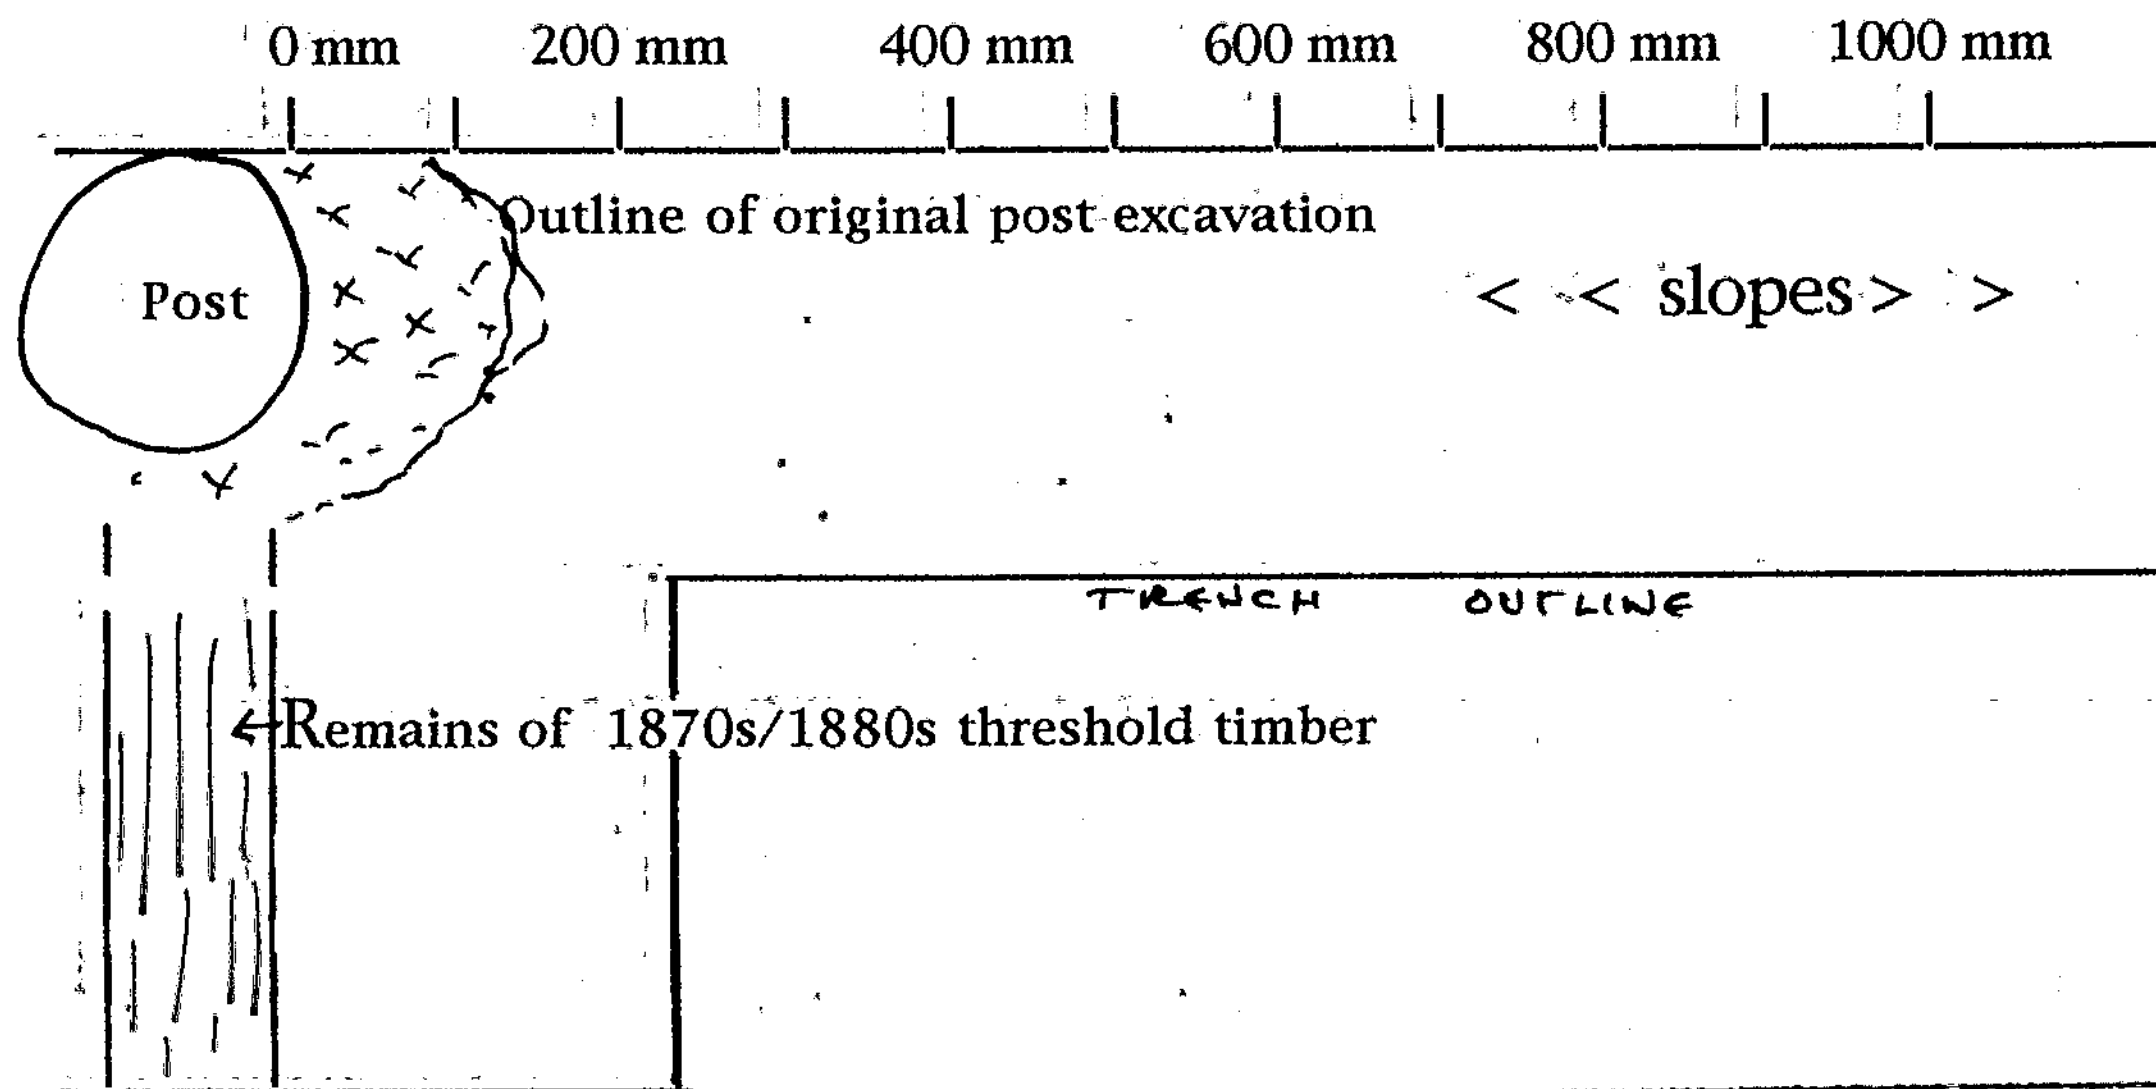
EAST ELEVATION TEST TRENCH---PLAN

This trench was situated at the north side of the barn's east double gateway. Evidence was found that there used to be a threshold timber along the gateway, secured by a large spike at each end, on analogy with the ones seen securing the large floor plates, or bearers, seen in the south half of the structure (probably dating circa 1880s). This shows that there has been a slight build-up of surface soil over the last hundred and twenty or so years in this area.

The original, roughly circular, excavation and backfill for the gateway post became distinct during the excavation. The area directly against the post was of a dark hue, basically loam, the result of timber rotting. The build-up of the loam was not dense because of ant excavation activity. Grass was found to be exploiting the loam against the post, the roots extending into the cracks along the post. Live termites, probably the Latex Termite (*Coptotermes acinaciformis*), were seen along the edge of the post and other posts of the structure. There was no sign of a drainage system, other than informal or natural drip-line trenching.
