Proposed Toilet Facilities, Royal Engineer's
Complex, (H 30 A and H 30 B).

KAVHA and Report 8 part II

June 1982

Commonwealth Department of
Transport and Construction.

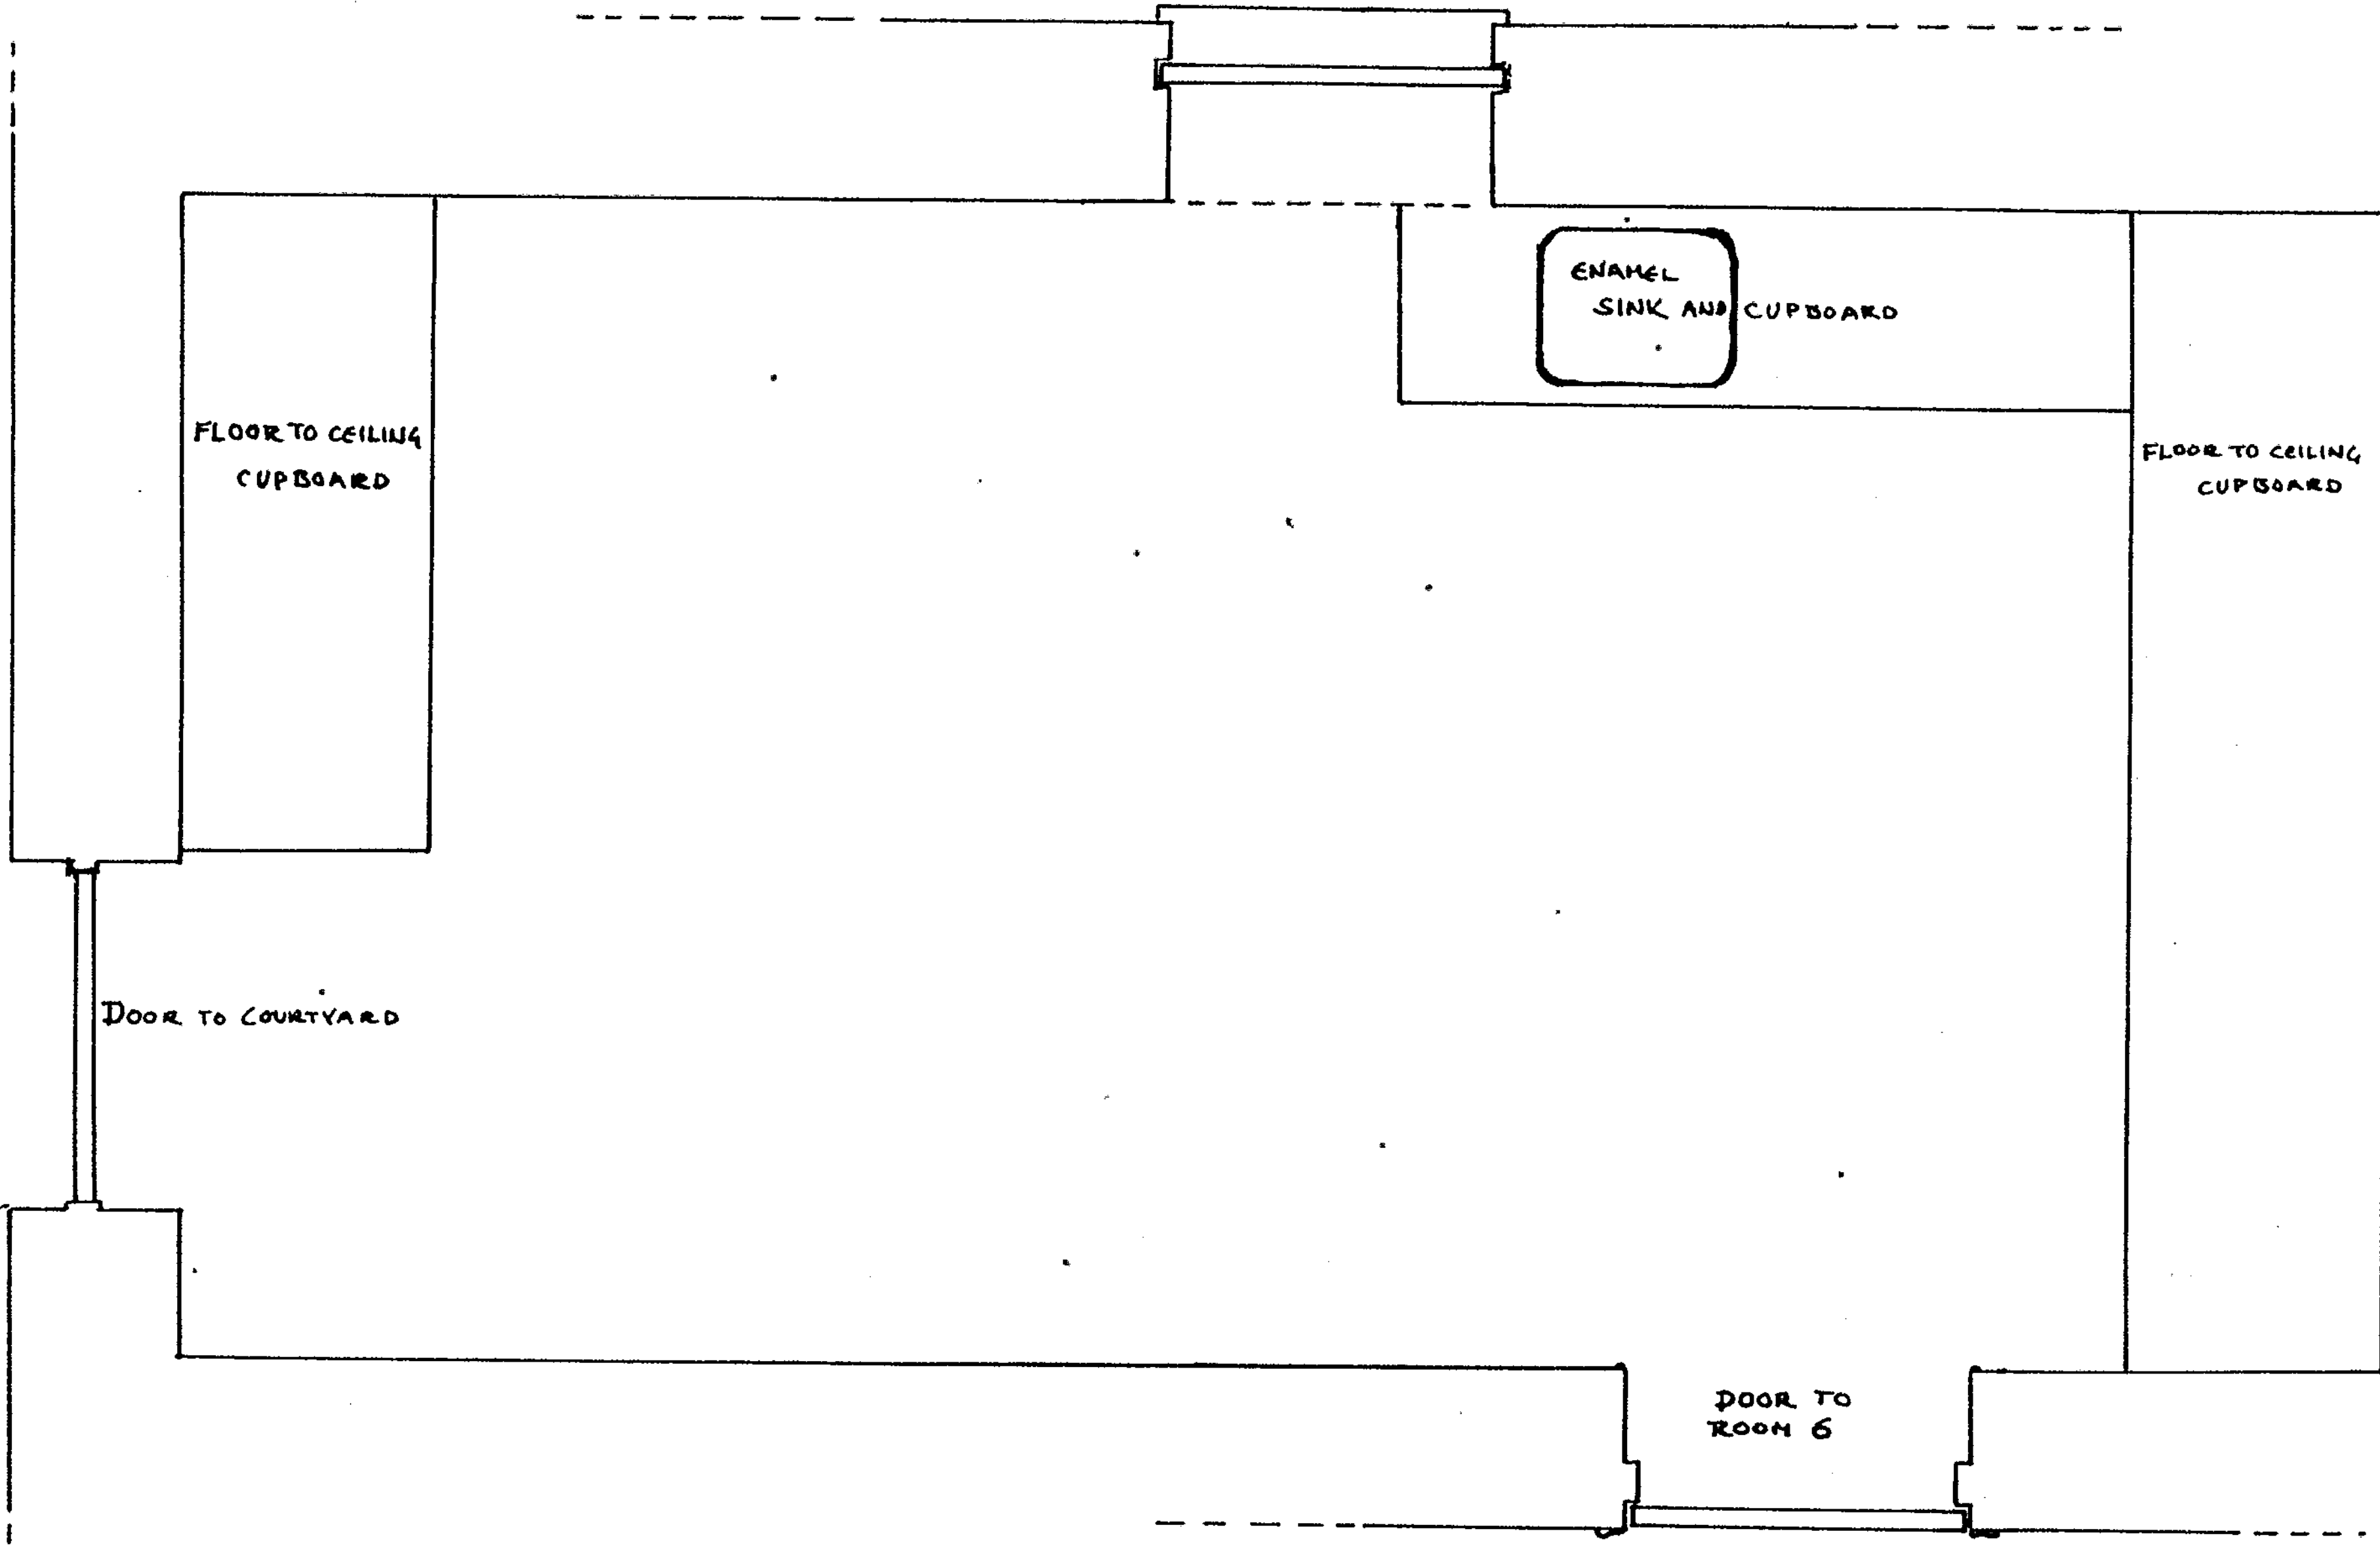
H30 A ROYAL ENGINEER'S OFFICE, ROOM 4.

The cupboards are of timber and are built onto the timber wall cladding. These date to the installation of the cladding. The position of the cupboards may be seen in ill. 1.
