DRAINAGE
REPORT
TIMBER
BARN
ROUSE HILL
HOUSE

By: Dr Robert V J Varman

For: Historic Houses Trust of New South
Wales

JUNE 23, 1997

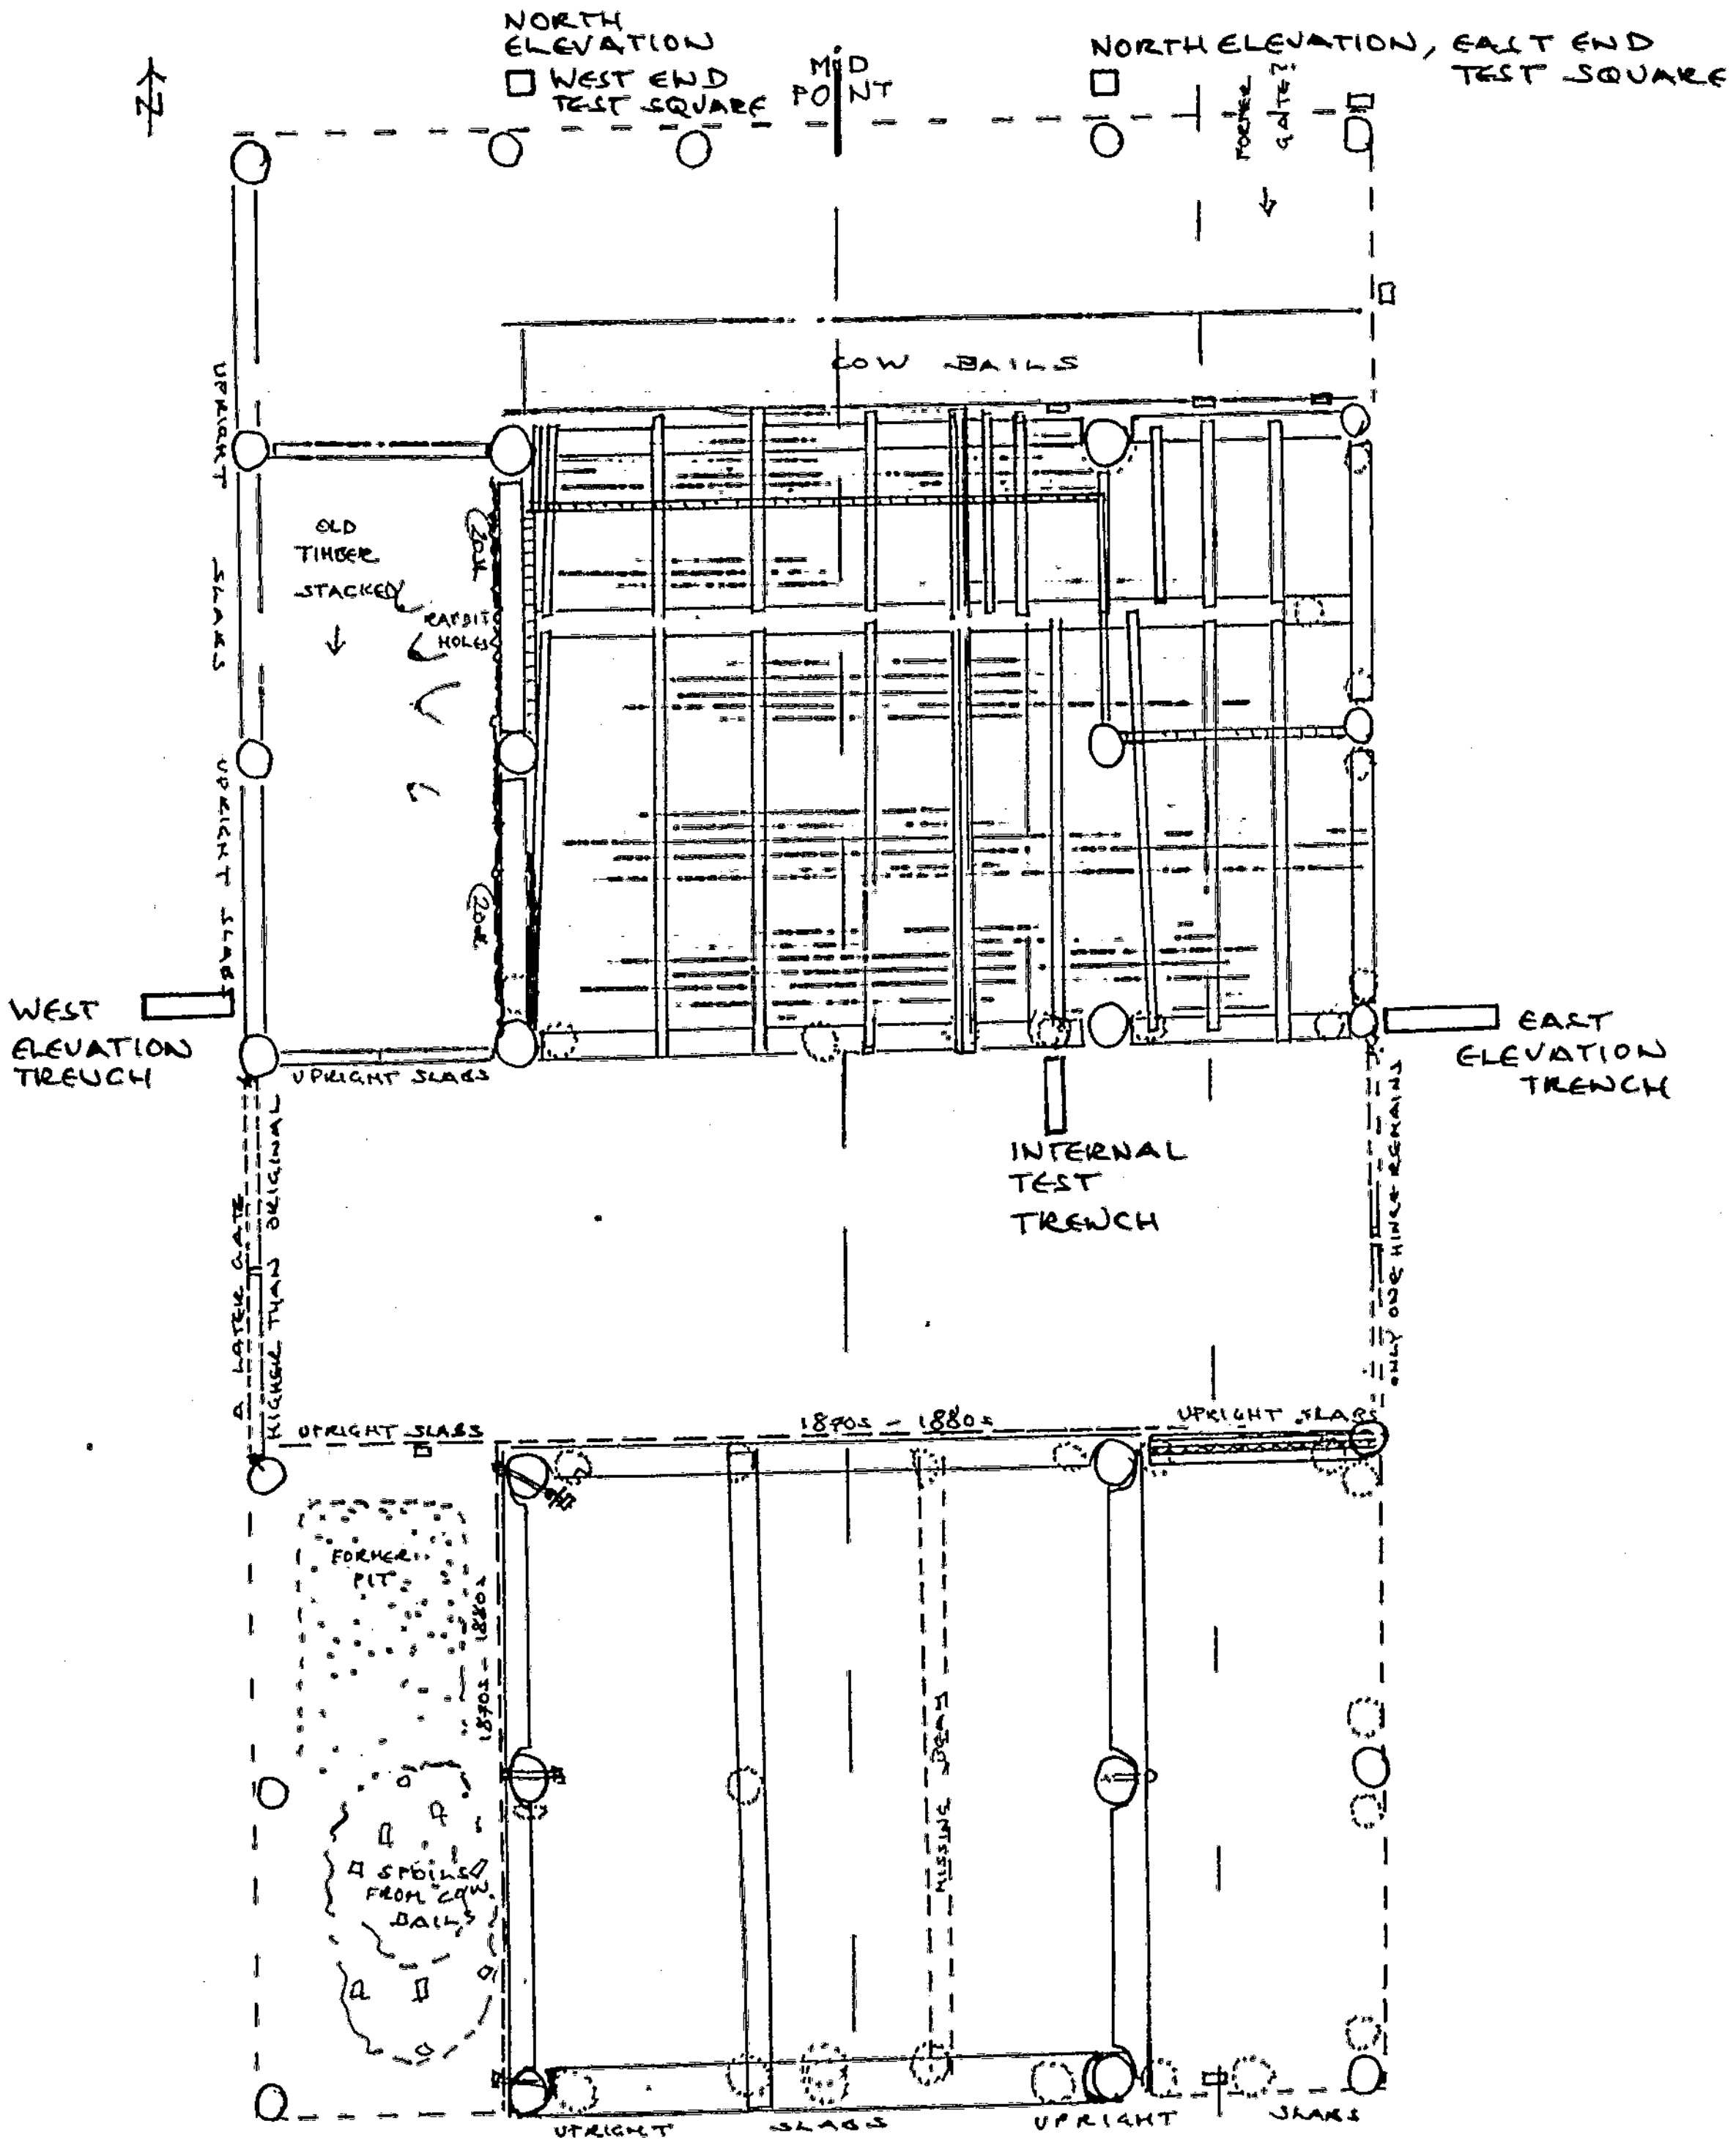
BARN ROUSE HILL HOUSE

EAST TRENCH

This trench was situated at the north side of the barn's east double gateway. Evidence was found that there used to be a threshold timber along the gateway, secured by a large spike at each end, on analogy with the ones seen securing the large floor plates, or bearers, seen in the south half of the structure (probably dating circa 1880s). This shows that there has been a slight build-up of surface soil over the last hundred and twenty or so years in this area.

The original, roughly circular, excavation and backfill for the gateway post became distinct during the excavation. The area directly against the post was of a dark hue, basically loam, the result of timber rotting. The build-up of the loam was not dense because of ant excavation activity. Grass was found to be exploiting the loam against the post, the roots extending into the cracks along the post. Live termites, probably the Latex Termite (*Coptotermes acinaciformis*), were seen along the edge of the post and other posts of the structure. There was no sign of a drainage system, other than informal or natural drip-line trenching.

[1] Reduce the moisture content of the soil under the Barn.
